## *A Investigation on the Actual Condition of PV Maintenance on Residential Buildings*

Lee, Eung-Jik\*

### ABSTRACT

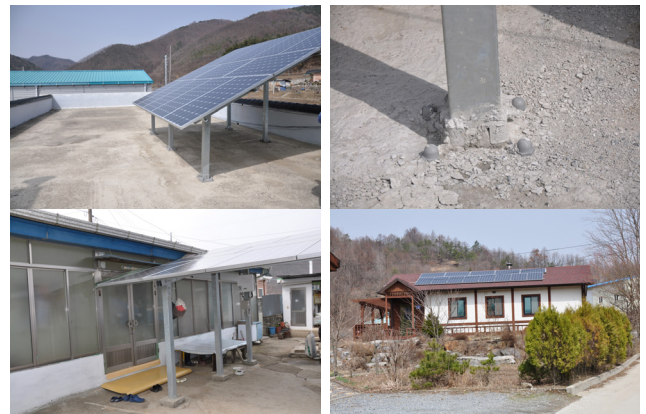
Fig. 2. Condition of the surveyed facilities

The solar panels were in good condition as a whole in terms of cleanness and they were fixed fast on the supports. However, some panels were polluted with dirt and found to have some problems on the back of the panels in terms of the attachment of Styrofoam and installation location.

The appearance of inverters was also clean and no abnormalities were found such as peculiar noise or smell. Besides, they were correctly installed below the array of the solar panels except two facilities that were installed on the rail of the top, so they were exposed to external environment such as snow and rain.

Some of the households have the support structures of PV power system installed in unsuitable space due to lack of space and thus where the shade of a building covers the system. Furthermore, the shapes of the array of PV power facility are monotonous and single layered<Fig. 2>.

This insufficiency evidences that no proper and enough preparation is made when a builder make a plan and starts construction. It is very essential to place the size, shape and direction of a house in consideration for installing PV power system. Particularly, it is required that installation of PV power system in an old house should be considered and analyzed in the

context of the life cycle of the system and a house building. As a result, efficient operation of the system can be realized and it will be led to a good maintenance of the system.
